Tank 4 Update

November 14, 2011

Presented to: Citizens Advisory Board

Savannah River Remediation

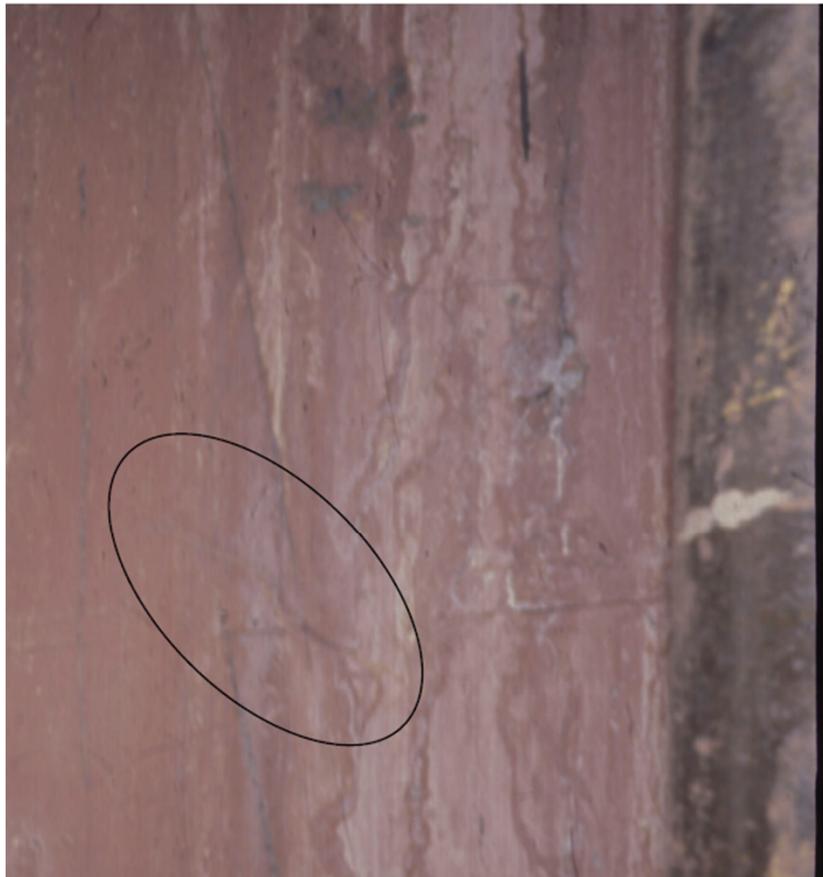
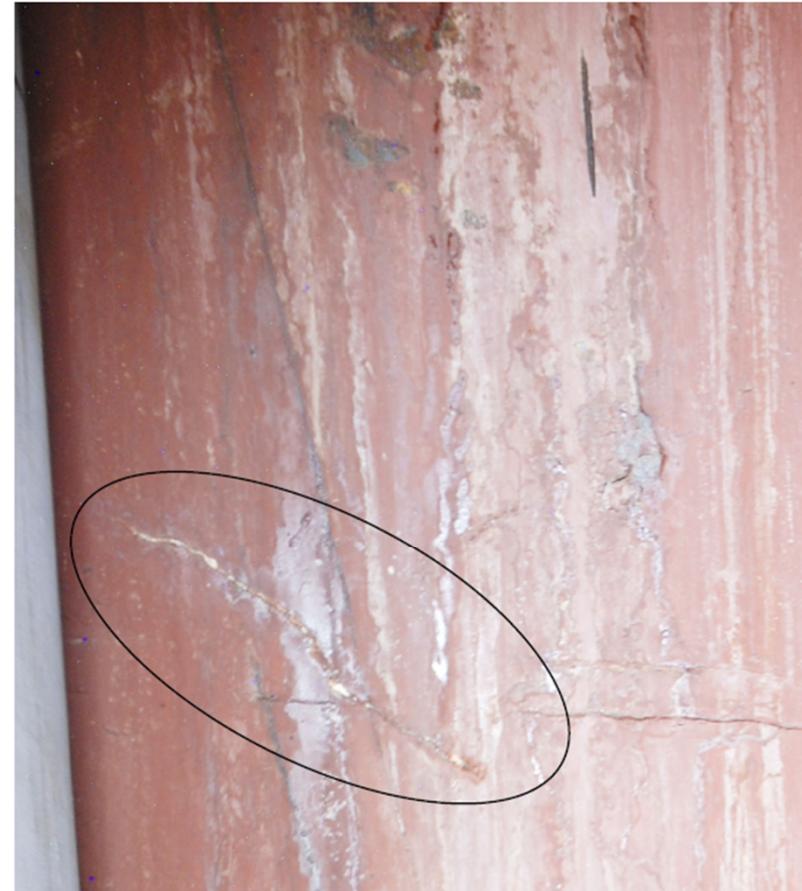
Tank 4 Visual Inspection Results

- 2011 inspection photo provided evidence of an indication in the wall of Tank 4, an old-style Type I tank
- After comparison to past photos it was declared a crack
- The operating level for the last 20 years has been below the crack location (234 in).
- The location of the newly identified crack is consistent with our known degradation mechanisms (SCC) for a non heat treated Type I Tank.

- The structural integrity of the tank remains sound with a high margin
- The leak integrity will be maintained by limiting liquid volume below the crack site
- A specific inspection plan will be developed to reduce the risk of leaks in tank 4 during waste removal operations
